DRAFT FINAL REPORT

36 MONTH
DELIVERABLE

APPENDIX 2.5: Overview of existing pathology databases

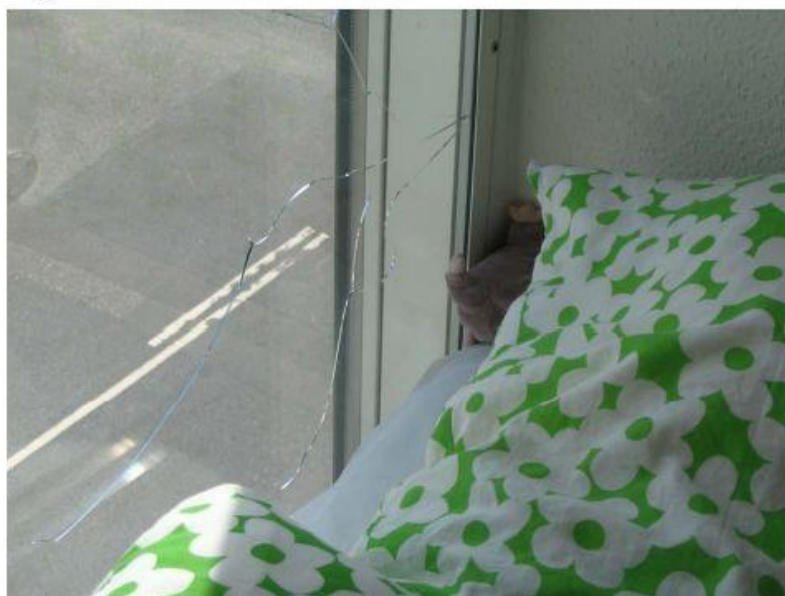
Lydrude med revnedannelser

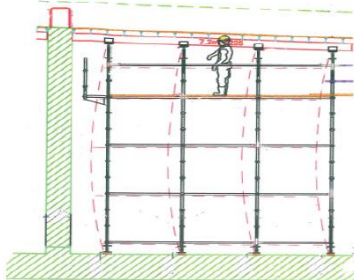
Diagram of shuttering support
